**Docket No. 217 – Development and Management Plan Inspection**

Northeast Utilities Service Company Certificate of Environmental Compatibility and Public Need for the construction of a 345-kV electric transmission line and reconstruction of an existing 115-kV electric transmission line between Connecticut Light and Power Company's Plumtree Substation in Bethel, through the towns of Redding, Weston, and Wilton, and to the Norwalk Substation in Norwalk, Connecticut.

**Date:** January 19, 2006

**Location:** 115 kV Underground Route

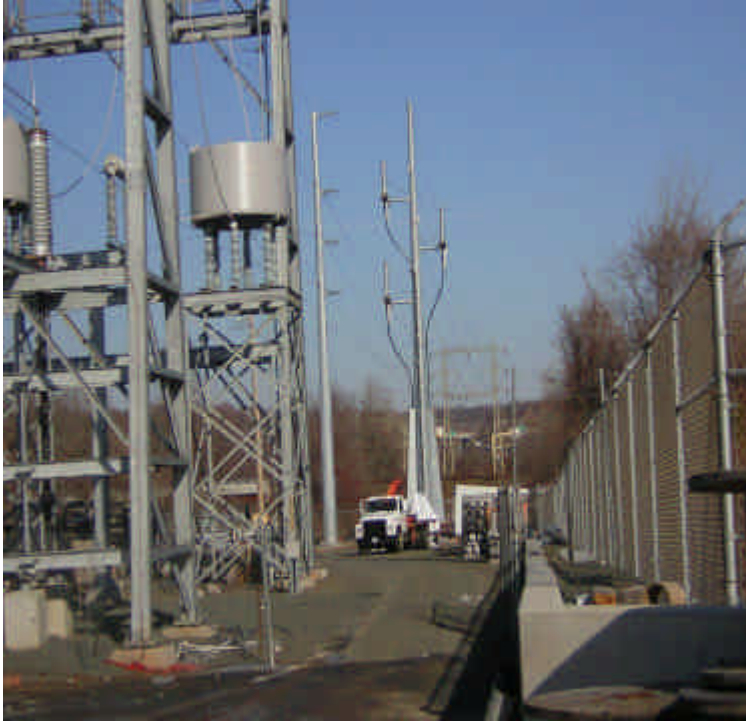
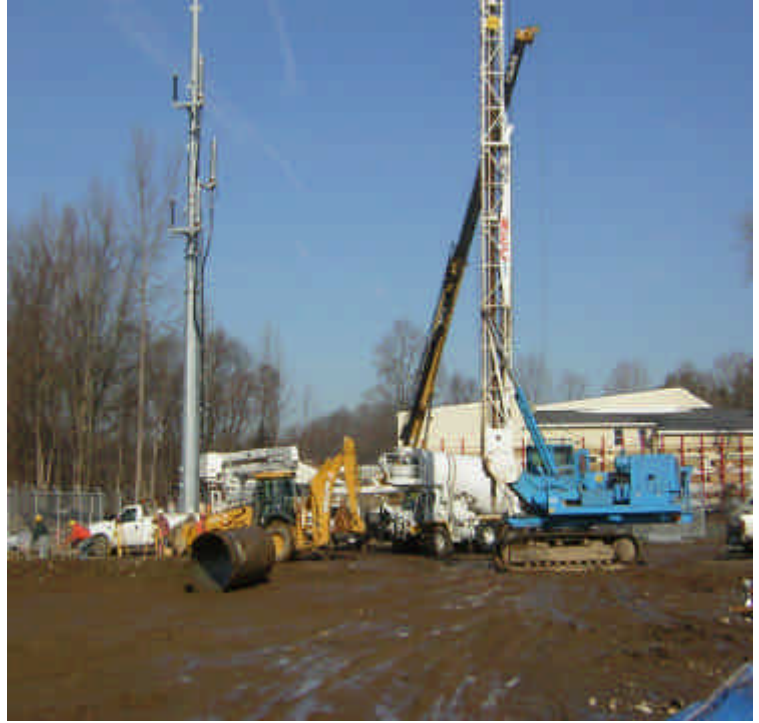
**115kV (ROW and Norwalk Junction):** Photo on the left –background- shows a view of the structure adjacent to the Norwalk substation. Photo on the right shows a view of the structure at Norwalk Junction. Scaffolding was removed from both and work was complete. 1/19/06

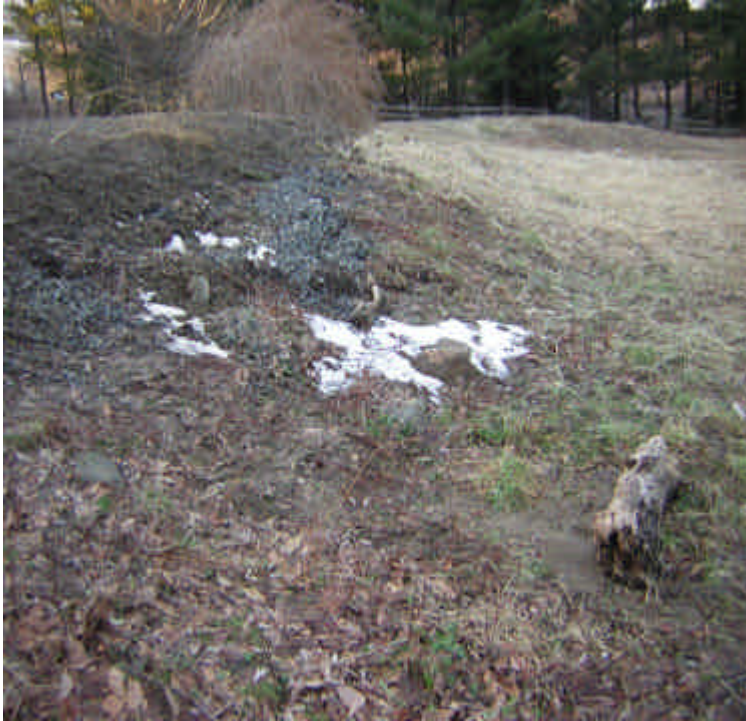
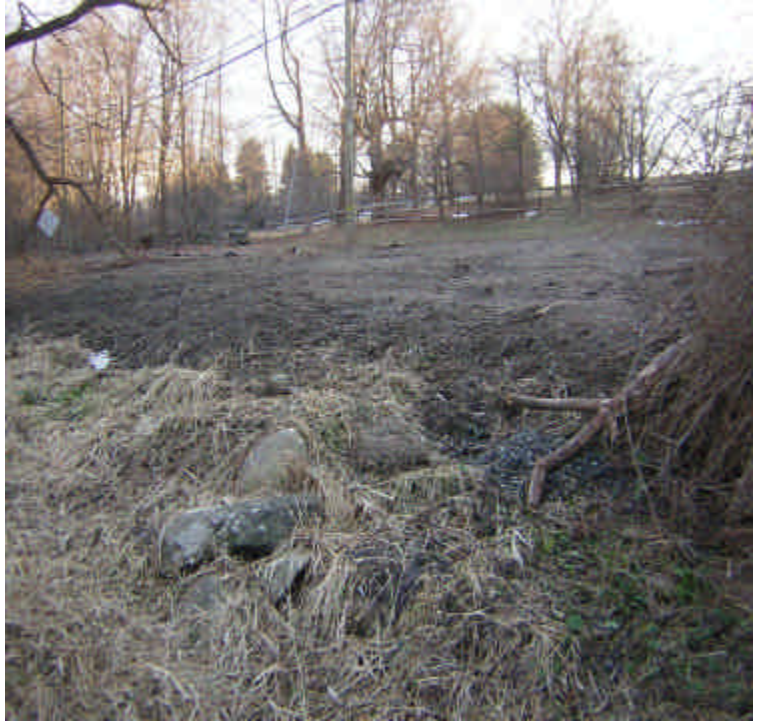
**115kV (Rt. 107):** Both photos show views of the Rt 107 turn storage area. Rains created some erosion and rills and some slight sedimentation was noted along the base of the slope. The area will be placed with silt fence or haybales early the following week. 1/19/06

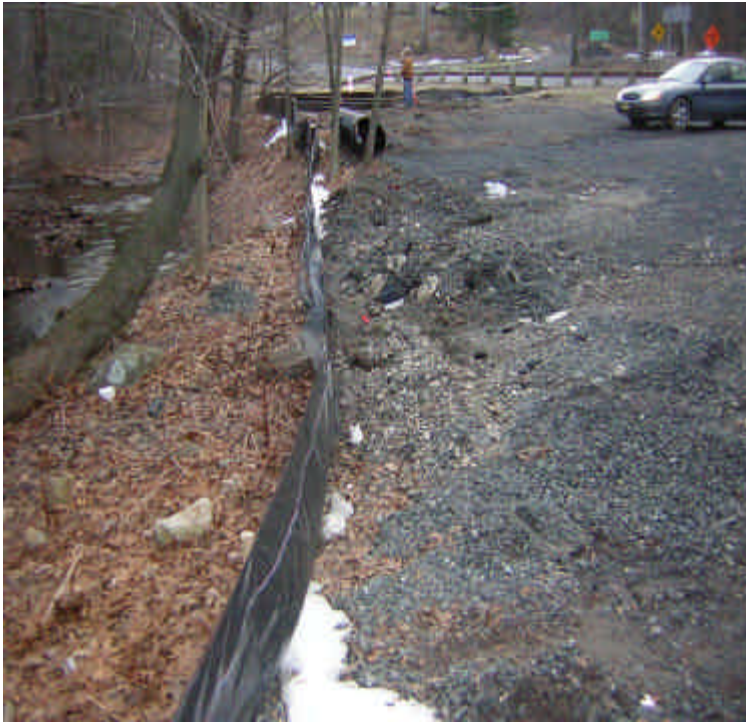
**115kV (Rt.58). Photo on the left shows Putnam Park with erosion controls in good shape. Photo on the right shows the Sunset Hill Rd. storage area. The recent rains caused erosion in the yard and sedimentation to the adjacent swale. Silt fence will also be installed here early next week. 1/19/06**

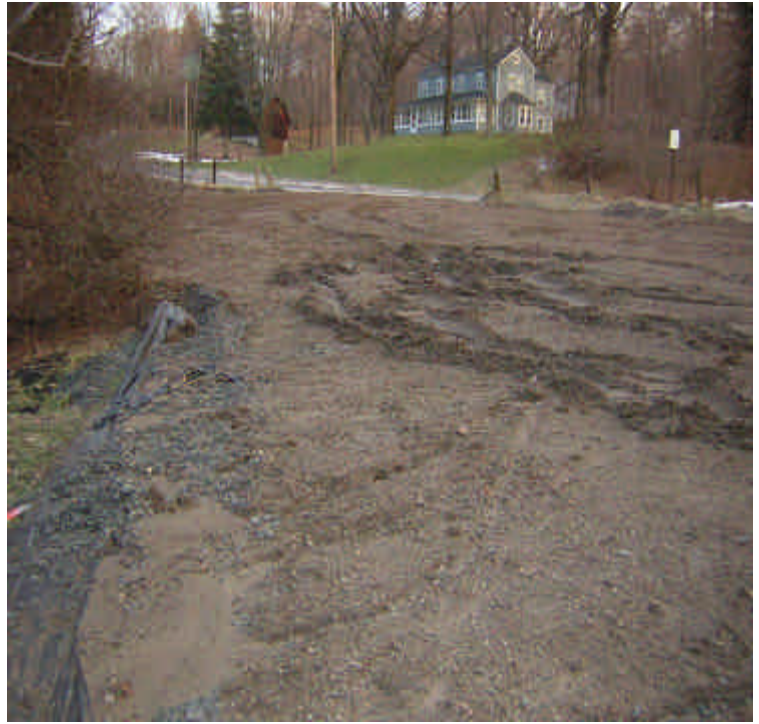
- Controls at the Putnam Park storage area are in good shape. 1/19/06	- None at this time. Controls should remain at this site until the growing season. 1/19/06
	-The status of the Sunset Hill Rd. storage area deteriorated following the rains. Gullies and erosion were noted across the yard and sedimentation occurred directly to the swale. 1/19/06	-Erosion controls will be installed early the following week. The yard should be mulched with straw. Soil in the swale is now significant along and down stream from the entire yard. It will need to be carefully shoveled out of the swale by hand ASAP to avoid further dispersal. 1/19/06
<b>Gallows Hill Road</b>	-The area is well stabilized. 1/19/06	- None at this time 1/19/06
<b>Rt. 107 (Lonetown Rd)</b>	- Minor erosion and rills were noted at the storage area south of the 90 degree turn on Rt. 107. Some sedimentation had occurred along the base of the slope following the rains. 1/19/06	- Erosion controls will be installed early the following week to prevent sedimentation to the wetland. The yard should be mulched with straw. 1/19/06

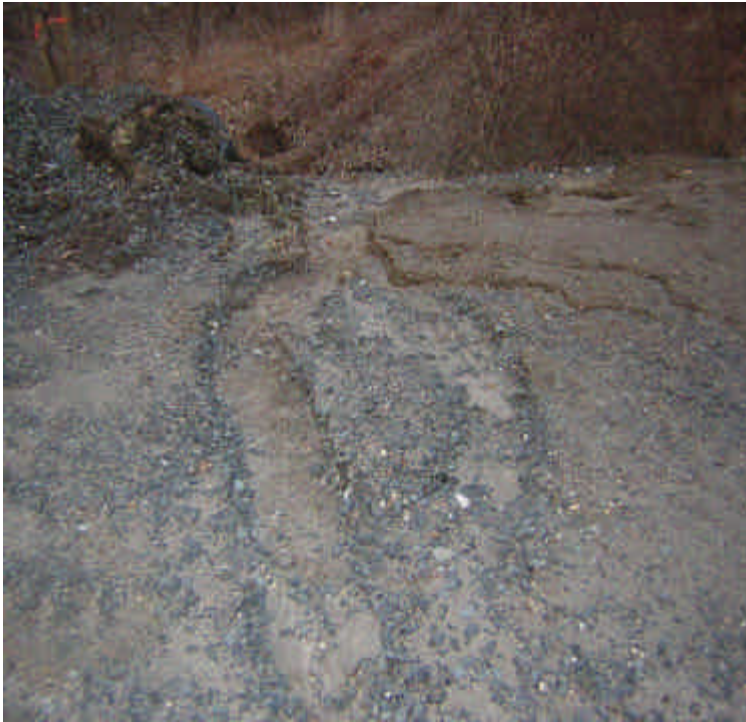
**Photo on the left shows some of the gullies created across the yard by run-off. Photo on the right shows deposits of the sediment within the swale. We also recommend that the swale be cleaned up by hand ASAP to avoid further dispersal of the soil. 1/19/06**
